# Manhole Inspection Summary

Manhole # S63I\_\_013MH

Insp Date: **6/3/08 2:12 PM**

**Location** Address: **639 Umbra St.**

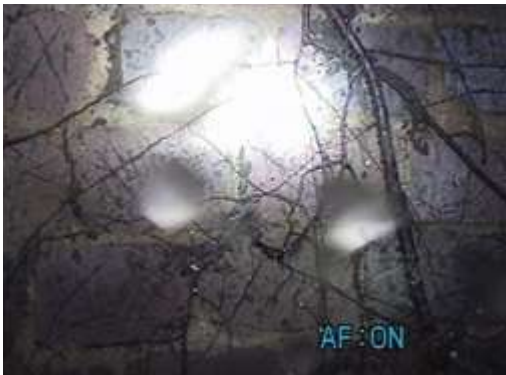
Defect 2

Root Intrusion

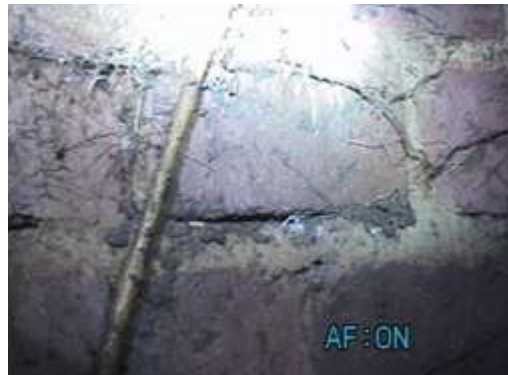
Defect 1

Comments **HEAVY ROOT INTRUSION IN BARREL.**

Root Intrusion

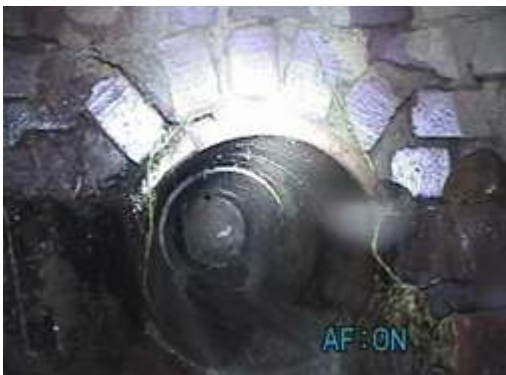
Defect 3

Fractured pipe seal. 10:00-11:00 on incoming 3 o'clock

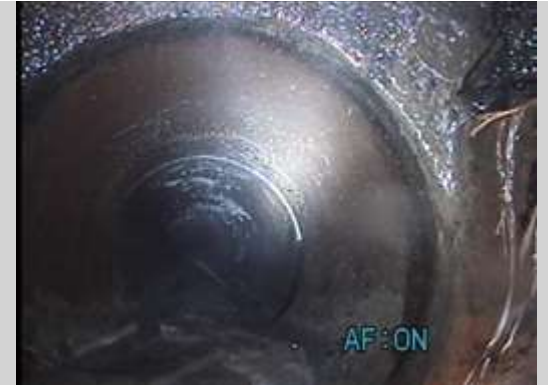
12 O'Clock Outflow

18 in. Circular Gravity Sewer  
Pipe Out @ 12 O'Clock

Pipe Height: **21.6** (in.) Rod Only (Angled)  
Pipe Material: **Clay** ☐ Pipe Lined  
Invert Depth: **30.67** (ft.) Flow Characteristics: **Fast**  
Deposits: ☒ None ☐ Mud ☐ Sludge ☐ Debris ☐ Grease  
Silt Depth: (in.) Deposits Extent:  
Infiltration: **None** Pipe Seal Cond: **Sound**

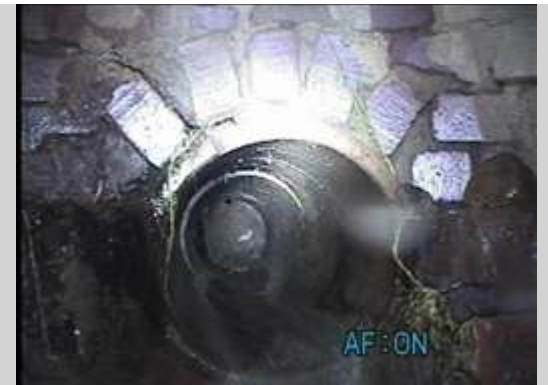
3 O'Clock Inflow

10 in. Circular Gravity Sewer  
Pipe In @ 3 O'Clock

Pipe Height: **9.6** (in.) Rod Only  
Pipe Material: **Clay** ☐ Pipe Lined  
Invert Depth: **29.25** (ft.) Flow Characteristics: **Fast**  
Deposits: ☒ None ☐ Mud ☐ Sludge ☐ Debris ☐ Grease  
Silt Depth: (in.) Deposits Extent:  
Infiltration: **None** Pipe Seal Cond: **Cracked**

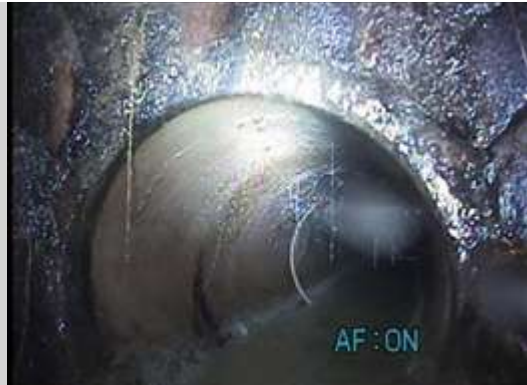
9 O'Clock Inflow

12 in. Circular Gravity Sewer

Pipe In @ 9 O'Clock

Infiltration: **None** Pipe Seal Cond: **Sound**
